Test Case: ATEX OLFS Filter systems
Location : Germany ERDGASVERDICHTER STATION MALLNOW
Customer: Wingas
Application: Gas turbines
Brand Model: MAN FT- 8 Gasturbine
Filtersystems : OLFS 58-1 and OLFS 58-6 pack ATEX

Field test case OLFS ATEX system

This next case was done by one of our partners in Finland **Fluid Intelligence Oy** specializing in machine maintenance and contamination management.

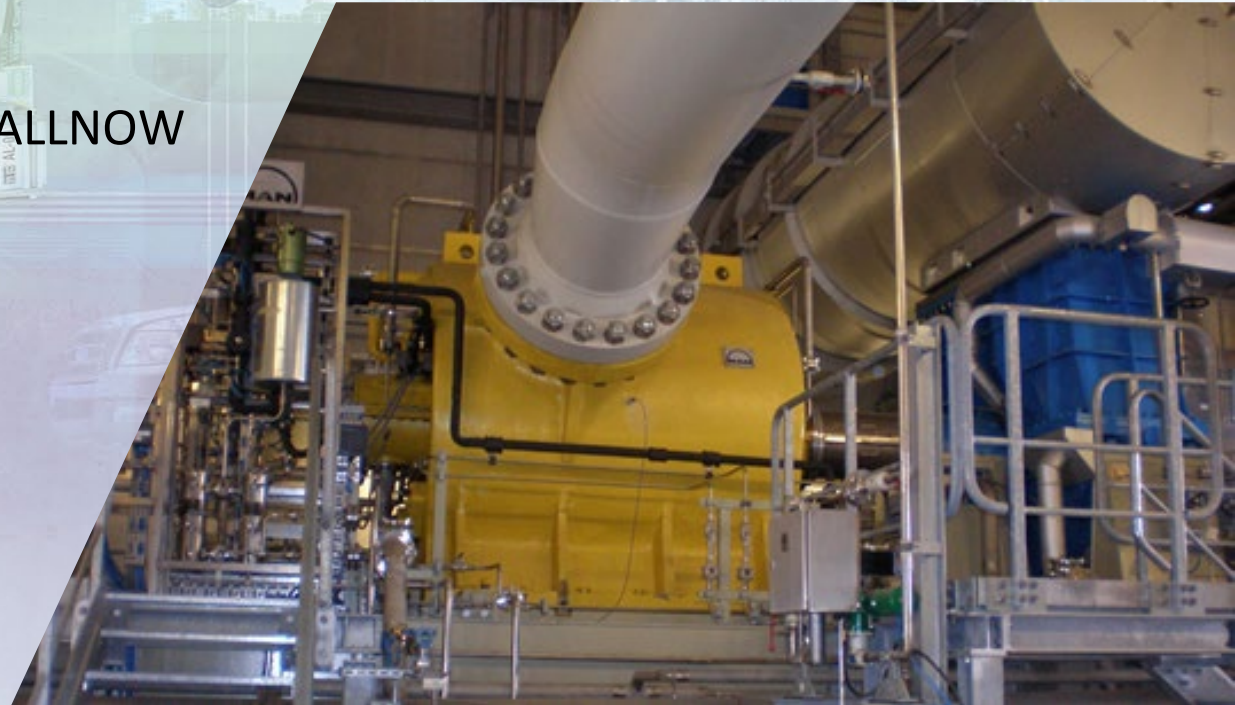
Anzahl der Verdichter:	3
Verdichterleistung:	ca. 75 MW (3 x 25 MW)
max. zul. Betriebsdruck:	100 bar
Kapazität:	3,34 Mio. m ³ /h (im Normzustand)
Antriebsart:	Gasturbine
Öl	Mobil Jet 245 (26,4 cSt @ 40 C)
Filter	OLFS-58/1-A-3,2 400 ATEX

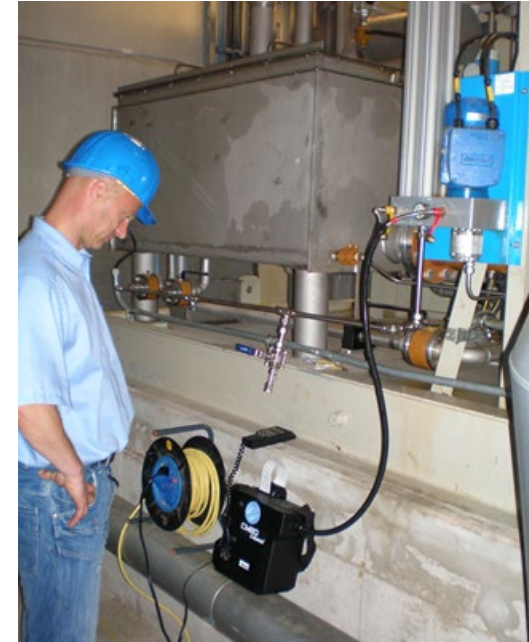
75% Dirt reduction in 18 hours ISO 15/13/11 to ISO 13/11/9

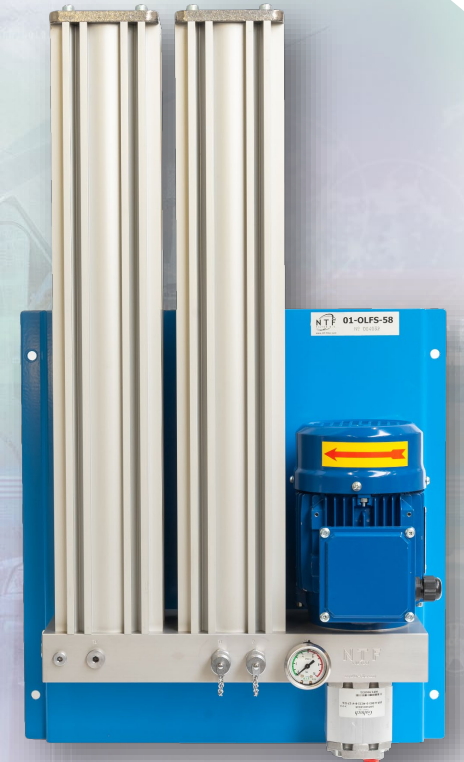
OLFS 58A / 2
NTF Radial Micro Filter
with a Retention value of
0,5 micron
and an official ratio
on 4 micron of
Beta (β) 4 > 10649
and
99,97 % efficiency
@ 2 micron particles

This was an OLFS 58/2 application on a turbine lubrication system from our partner Fluid intelligence in Finland maintenance specialists

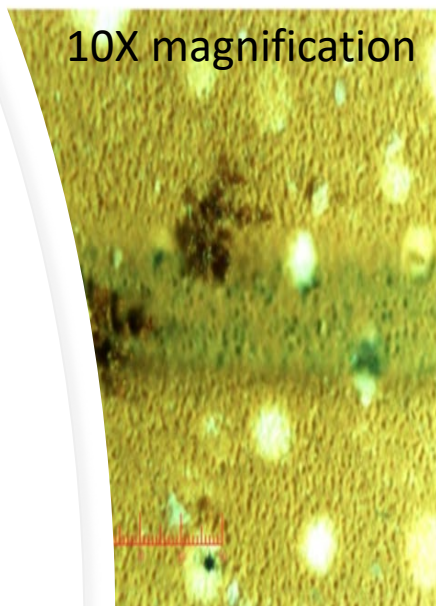
Mikroskooppikuva 3. 27.2.2019, ennen puhdistusta

10X magnification

Microscopic image
before filtering
ISO 22/19/15

ISO 4406:1999 luokka	Ennen suodatusta	22/19/15
ISO 4406:1999 luokka	Jälkeen suodatuksen	15/13/10

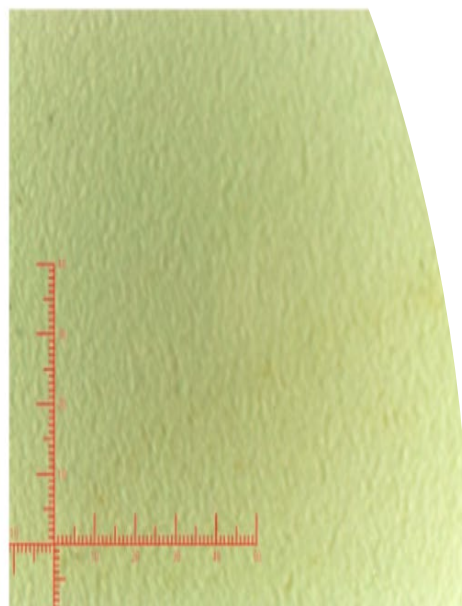
Mikroskooppikuva 4. 9.5.2019, jälkeen p.

Microscopic image
after filtering with NTF Filter
ISO 15/13/10

ISO 4406: Before filtering 22/19/15
ISO 4406: After filtration 15/13/10

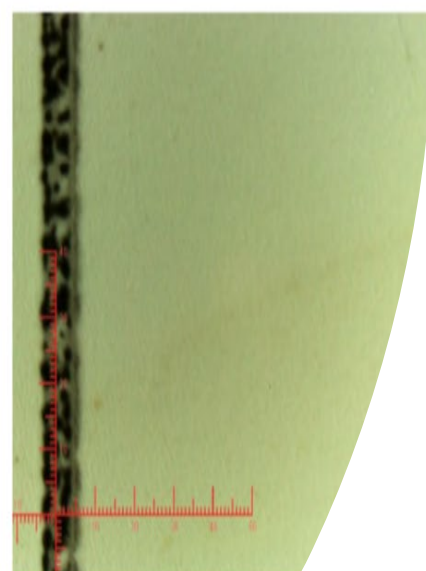
ISO 22/19/15

Membrane. 2/27/2019, before filtering

Membrane. 2/27/2019, after filtering
