**NTF Bypass filtration  
on Road Sweepers  
to prevent valve  
malfunctions**

# Road Sweepers Test cases

# Test case on a Mathieu Azura MC 120 Road sweeper

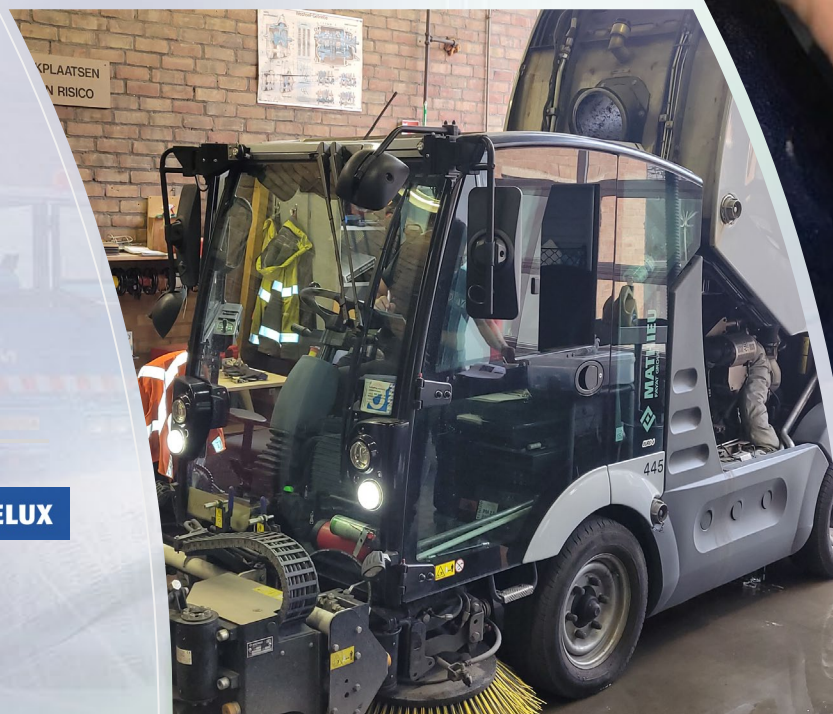
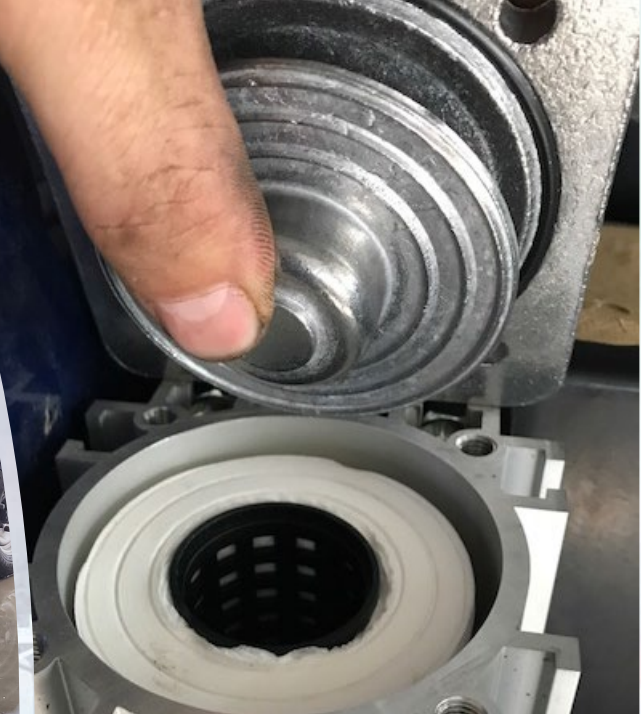
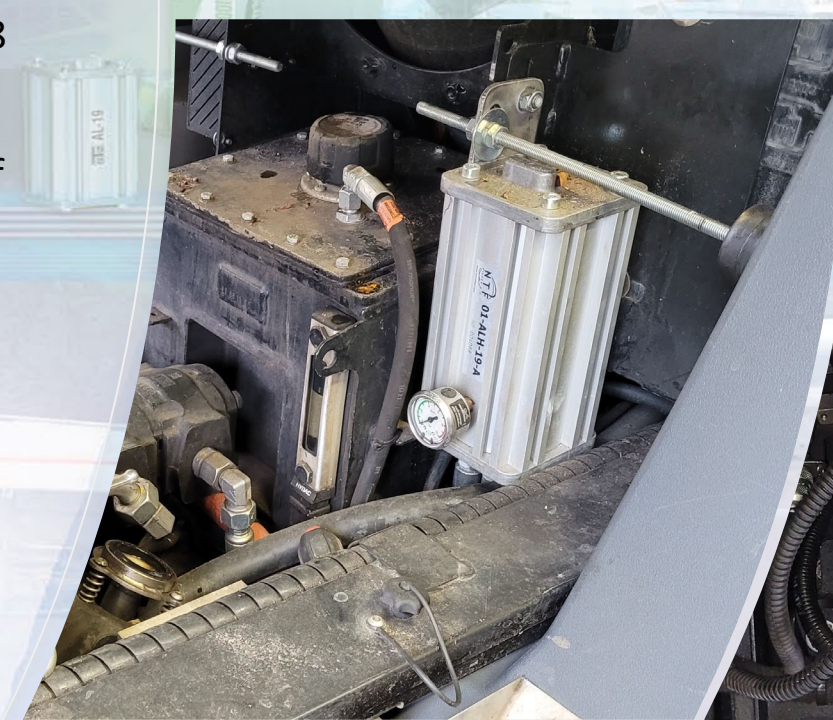
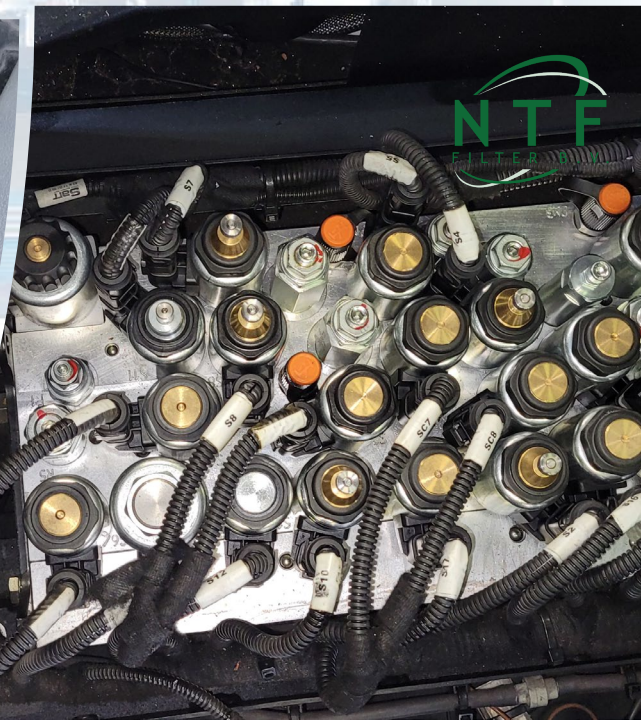
HVC Dordrecht Mathieu MC20 Azura Road sweeping machine									
Old oil 1000Hr +- 2538KM 3234Hours No NTF Filter									
Test nr.	Date	Time	ISO Code	4 micron	6 micron	14 micron	21 micron	38 micron	70 micron
Average of 5 counts	ISO		22/20/14	2.088.784	736.162	8.460	1590	104	6

Oil is heavily polluted and is far from the cleanliness class 16/14/11 and is now 22/20/14  
customer comments: frequent breakdowns and downtime

HVC Dordrecht Azura Start wiht NTF Filter ALH19A instald									
New oil from After oil change 2538KM 3234 start NTF Filter									
Test nr.	Date	Time	ISO Code	4 micron	6 micron	14 micron	21 micron	38 micron	70 micron
Average of 7 counts	ISO		19/16/11	397.936	58.770	2.048	761	134	8

The oil is changed but it is not clean enough for the valves that should be 16/14/11

HVC Dordrecht Azura 129 hours 886Km wiht NTF Filter ALH19A instald									
working oil from 3424KM 3363 Hours									
Test nr.	Date	Time	ISO Code	4 micron	6 micron	14 micron	21 micron	38 micron	70 micron
Average of 7 counts	ISO		14/12/9	12.981	3.547	317	151	39	2

notes: the oil is well within the oil cleanliness class ISO 16/14/11 and is now 14/12/9

HVC Dordrecht Azura 620 hours 2141Km wiht NTF Filter ALH19A instald									
working oil from 7217KM 3854 Hours									
Test nr.	Date	Time	ISO Code	4 micron	6 micron	14 micron	21 micron	38 micron	70 micron
Average of 9 counts	ISO		14/12/9	11.040	2.372	381	182	54	3

notes: the oil is well within the oil cleanliness class ISO 19/16/13 and is now 14/12/9  
customer comments: no more valve problems and oil looks very clean normally  
without filter the oil is already much darker

After an oil change the ISO cleanliness class was 19/16/11.  
After 620 hours the oil has become 91% cleaner.  
From ISO 19/16/11 to 14/12/9

Compared to the oil before changing, the oil is 99.21% cleaner !

From ISO 22/20/14 to 14/12/9

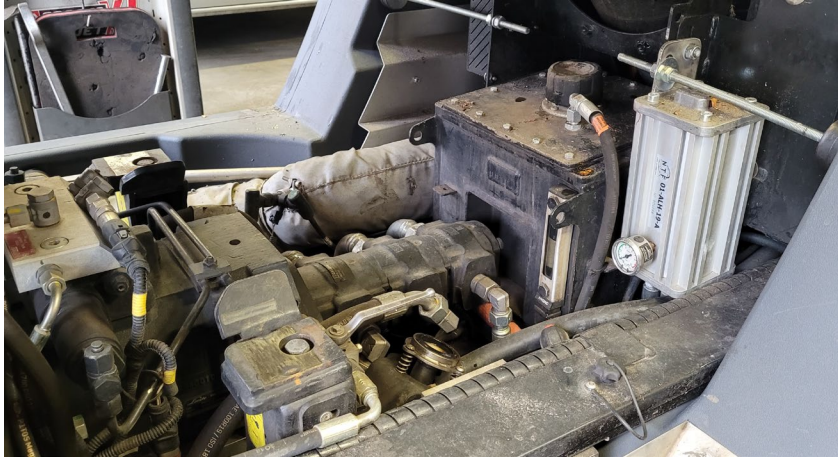
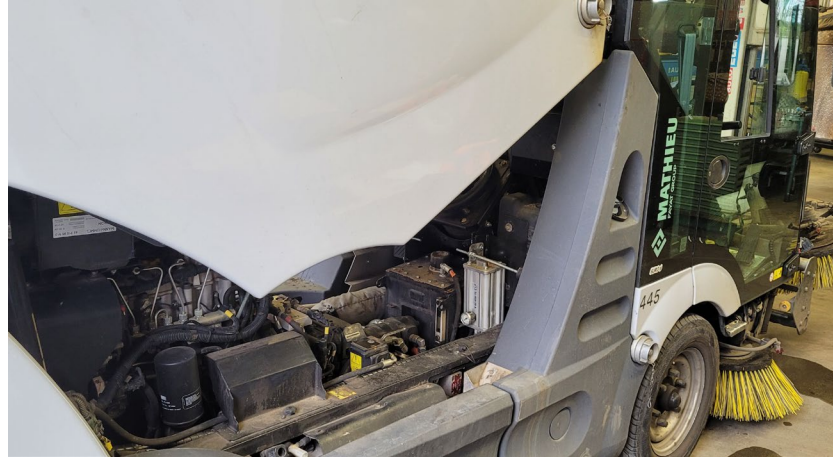
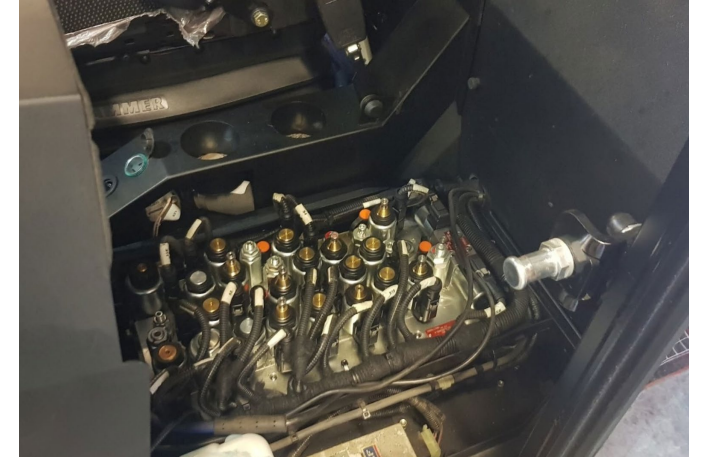
Oil remains clean even after 1051 hours  
129 hr      620 hr      1051 hr

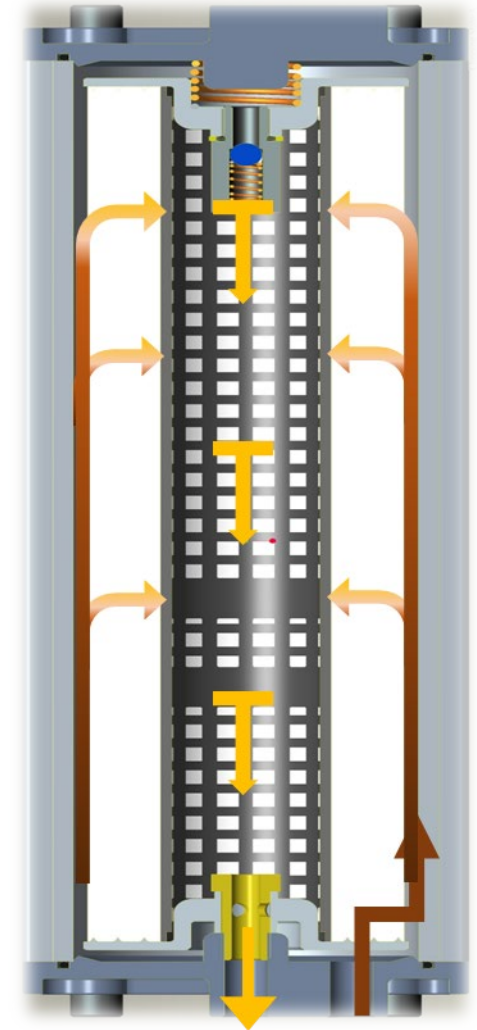
Principe bypass-microfiltratie voor motor, transmissie of hydrauliek

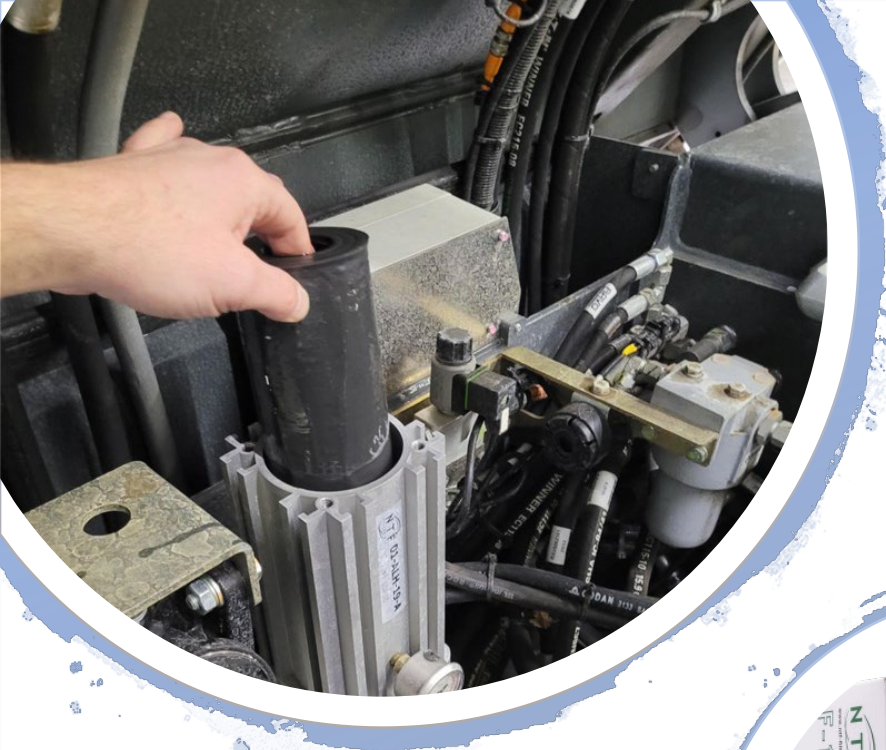
**Element after use is dirty !! But the oil is clean!!**

**The filter element can also absorb water!**

**Absorption capacity  
142ml H2O**

**Retention value: 0.5 micron**

**Beta ratio: Beta 2 > 2335**

**Beta ratio: Beta 4 > 10649**

**Efficiency: 99.97% @ 2  $\mu$**

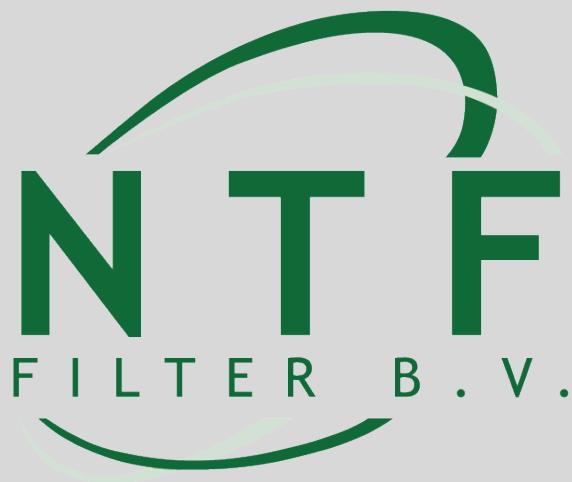
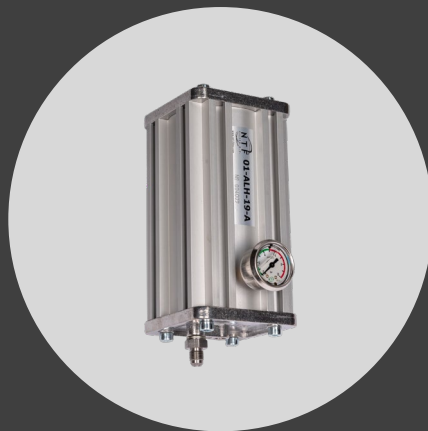
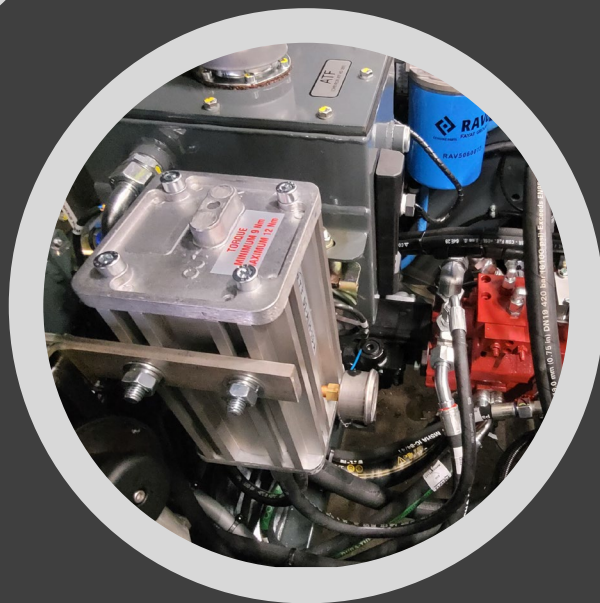
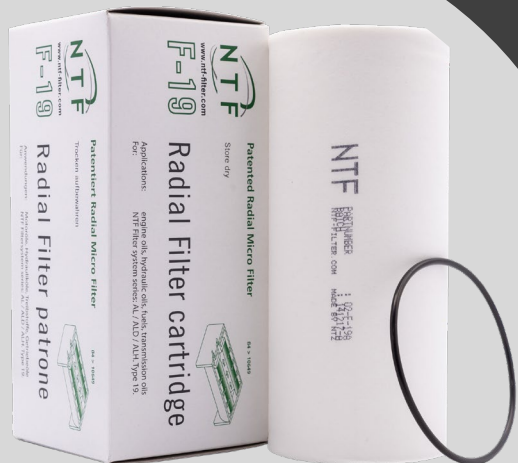
## ALH19A 420Bar Filter system for Ravo sweepers

### Contents of the kit :

1x ALH19A filter housing

1x F19A filter element

1x pressure gauge

1x Assembly set of bolts and nuts

1x Bracket

1x Hose set

**Can be installed within 1 hour!**
